CASE STUDY FOR NON-DESTRUCTIVE TESTING

Non Destructive Testing (NDT) and Temperature Data Indicate No Insulation in the Ceiling

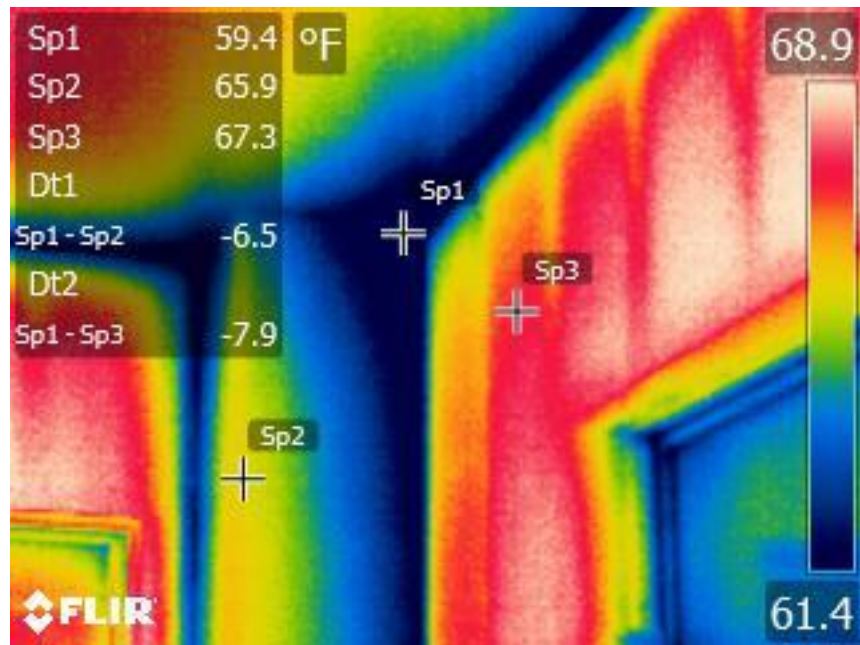
The thermal scan of the ceiling showed a strong thermal gradient with the demarcation line down the center of it. We suspected that the insulation was missing or severely compromised.

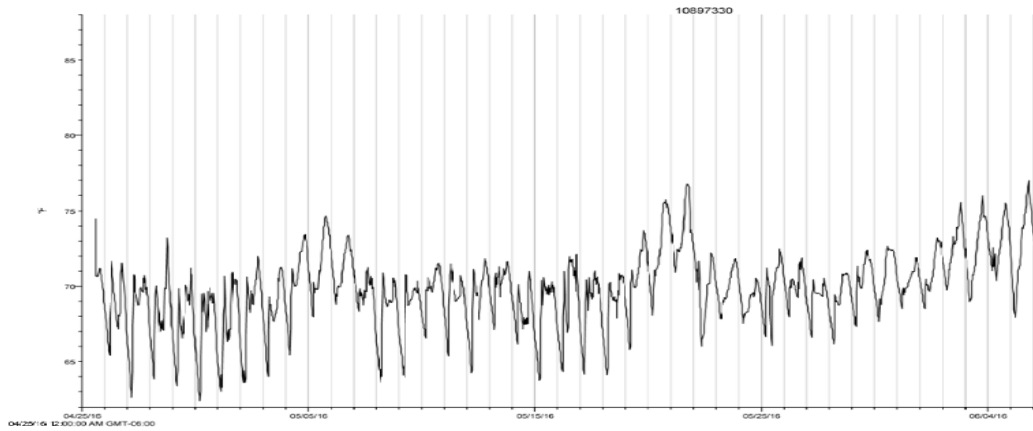
The second logger was located in the main living area and also controlled by the setback thermostat near the location of the data logger. The results were not surprising as the temperature logger mimicked the thermostat setback settings.

Temperatures in the back of the house with a set back thermostat.

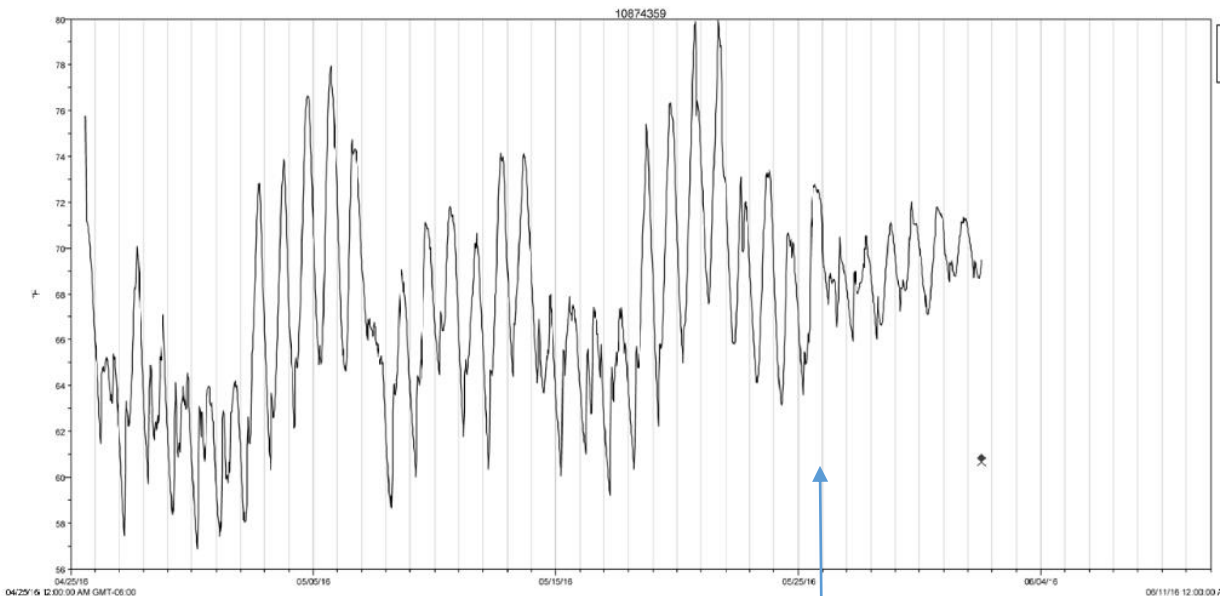
On May 25th when the hole was cut into the barrier wall, a visual showed that soffit baffles were installed, but the entire area was void of insulation. On June 1st the data from the Hobo™ loggers were downloaded to the software. The results were astounding. Prior to the insulation deficiency the temperature swings were between 12-16 degrees a day in the room without insulation. After the insulation was installed the swings lowered to 2-4 degrees a day.

Temperature in the front room. The insulation was installed on May 26th

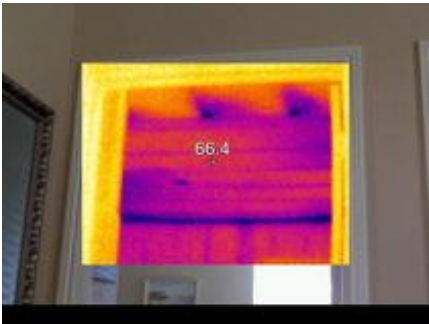
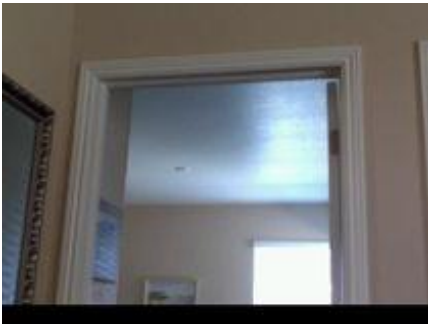
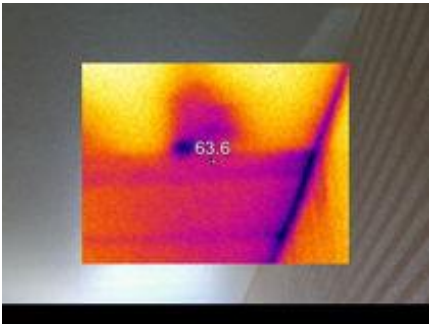
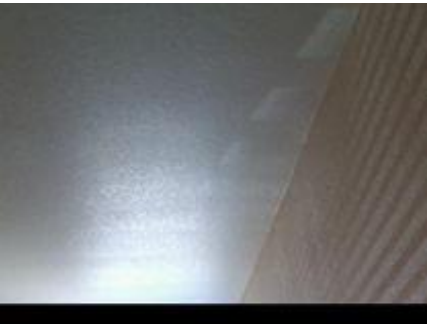
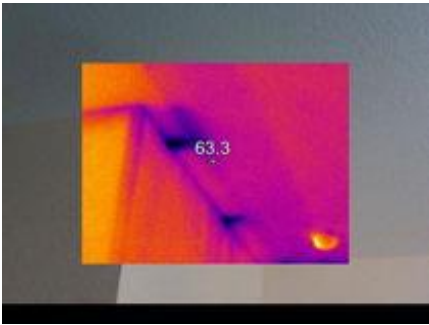
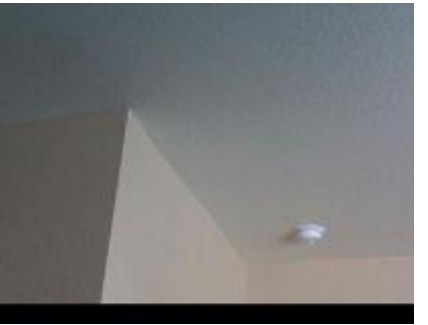
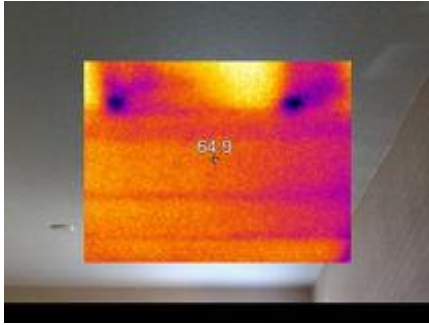
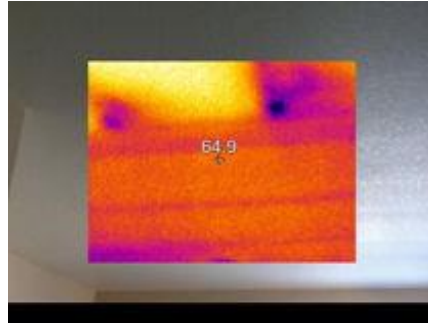
These pictures show the demarcation line between the insulated attic and the non-insulated attic.

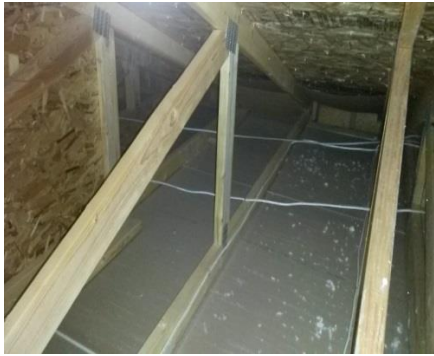
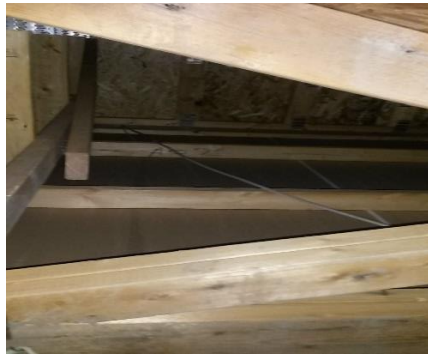
Digital photos of the attic space when the area was accessed through the knee wall in the garage. The insulating company completely missed this area of the home.
